International Business Machines Corporation
Office Products Division
Customer Engineering

Electronic Typewriter

Call Prevention Check

Model 50/60/75

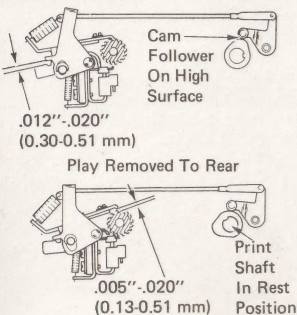
4 — Escapement Link

ESCAPEMENT

1 — Pawl Clearance

2 — Inhibitor

Inhibitor Enters Ratchet Notch Causing Slight Rotation With Ratchet Biased Top To Rear Then To Front

3 — Stop Screw

Manually Bottomed

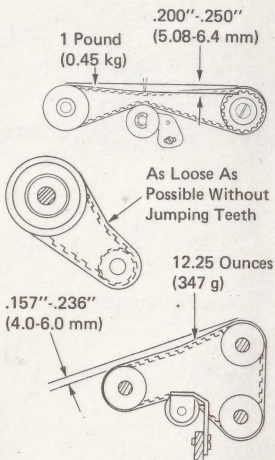
BELT TENSIONS

POWER MODULE

1 — Hold Carrier And Depress Backspace. Check:

$.008''-.012''$
(0.20-0.30 mm)

2 — Filter Bail Drive (Use The "B")

$.000''-.016''$ (0.38 mm)
Extra Motion After Pawl Restores
